First Detection Report of the Fall Armyworm *Spodoptera frugiperda* (Lepidoptra: Noctuidae) on Maize in Myanmar

⁴ Director (Head), Plant Protection Division, Department of Agriculture, Ministry of Agriculture, Livestock and Irrigation, Myanmar

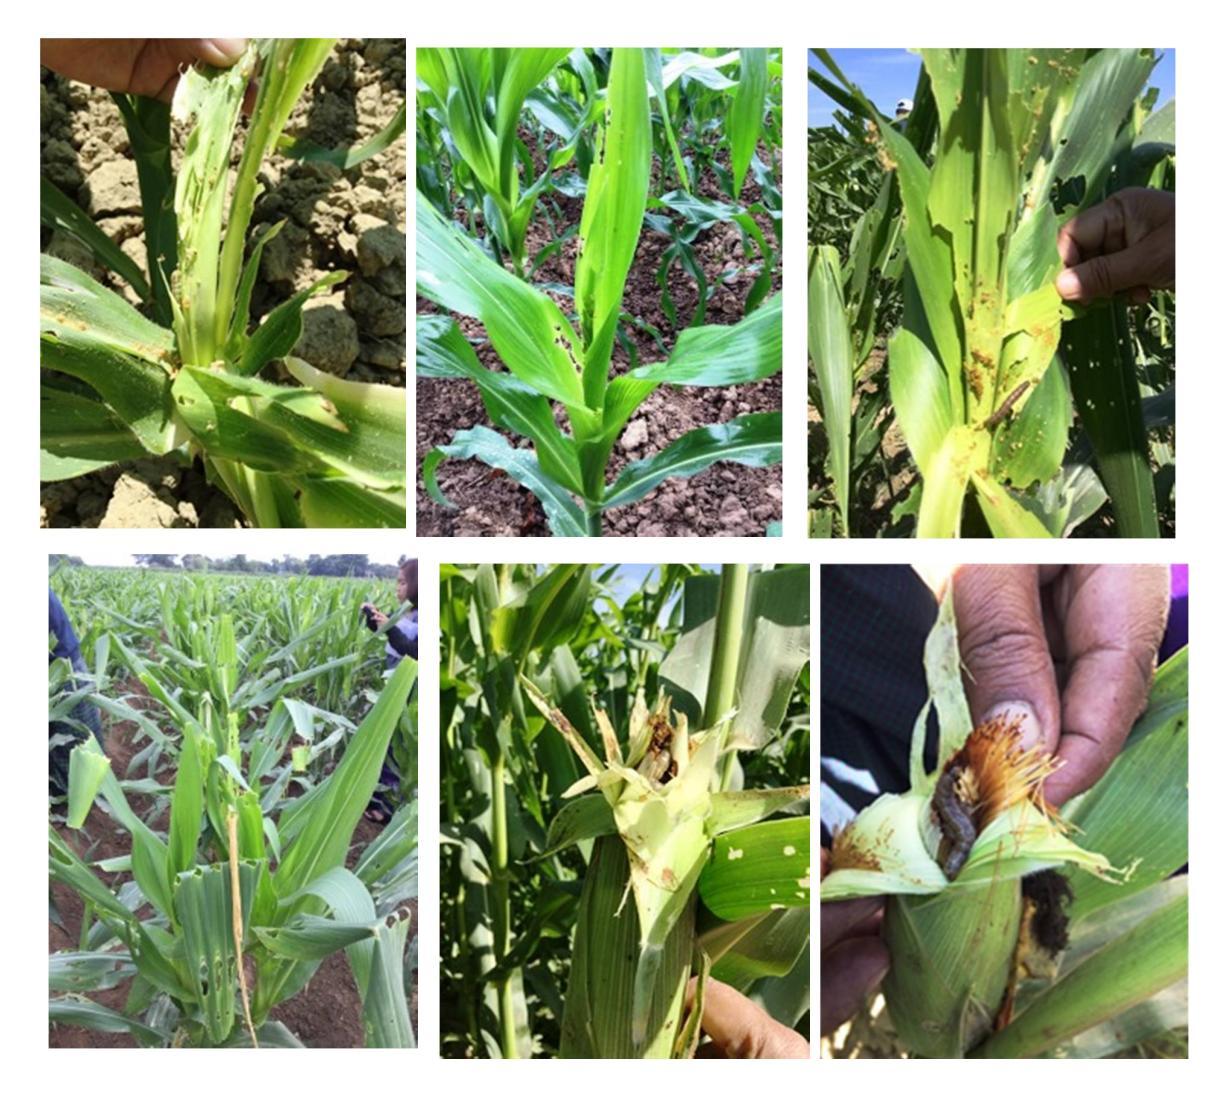
Within the observed maize fields, the whorls of maize plants attached with egg masses, larva and their frass, windowing and many shot holes on young plants as well as paper dolls symptoms on older leaves were found (Figure 1). Moreover, the characteristics of the observed larvae (Figure 2) were matched exactly with the characteristics of the Fall Armyworm *Spodoptera frugiperda* larvae in different literatures (Diedrich Visser et al. 2017; B.M. Prasanna et al. 2018; CABI 2018). For identification and confirmation, the egg masses and larvae were collected from the field and brought to the laboratory and reared at Fruit Fly Management Laboratory of PPD, Insein Township, Yangon, Myanmar. The larval stages and emerged adults were sorted and identified by Entomologists from PPD head office, DOA, based on external morphological characteristics using available keys and description (OEPP/EPPO 2015). Finally, we positively identified and confirmed that the pest is fall armyworm *Spodoptera frugiperda*.

Figure 1:Damage symptoms of the fall armyworm on maize plants, observed in Myin Gyan Township, Mandalay Region on 19th and 20th December 2018 and Hinthada Township and Zalon Township, Ayeyawaddy Region in Myanmar on 4th and 5th January 2019.

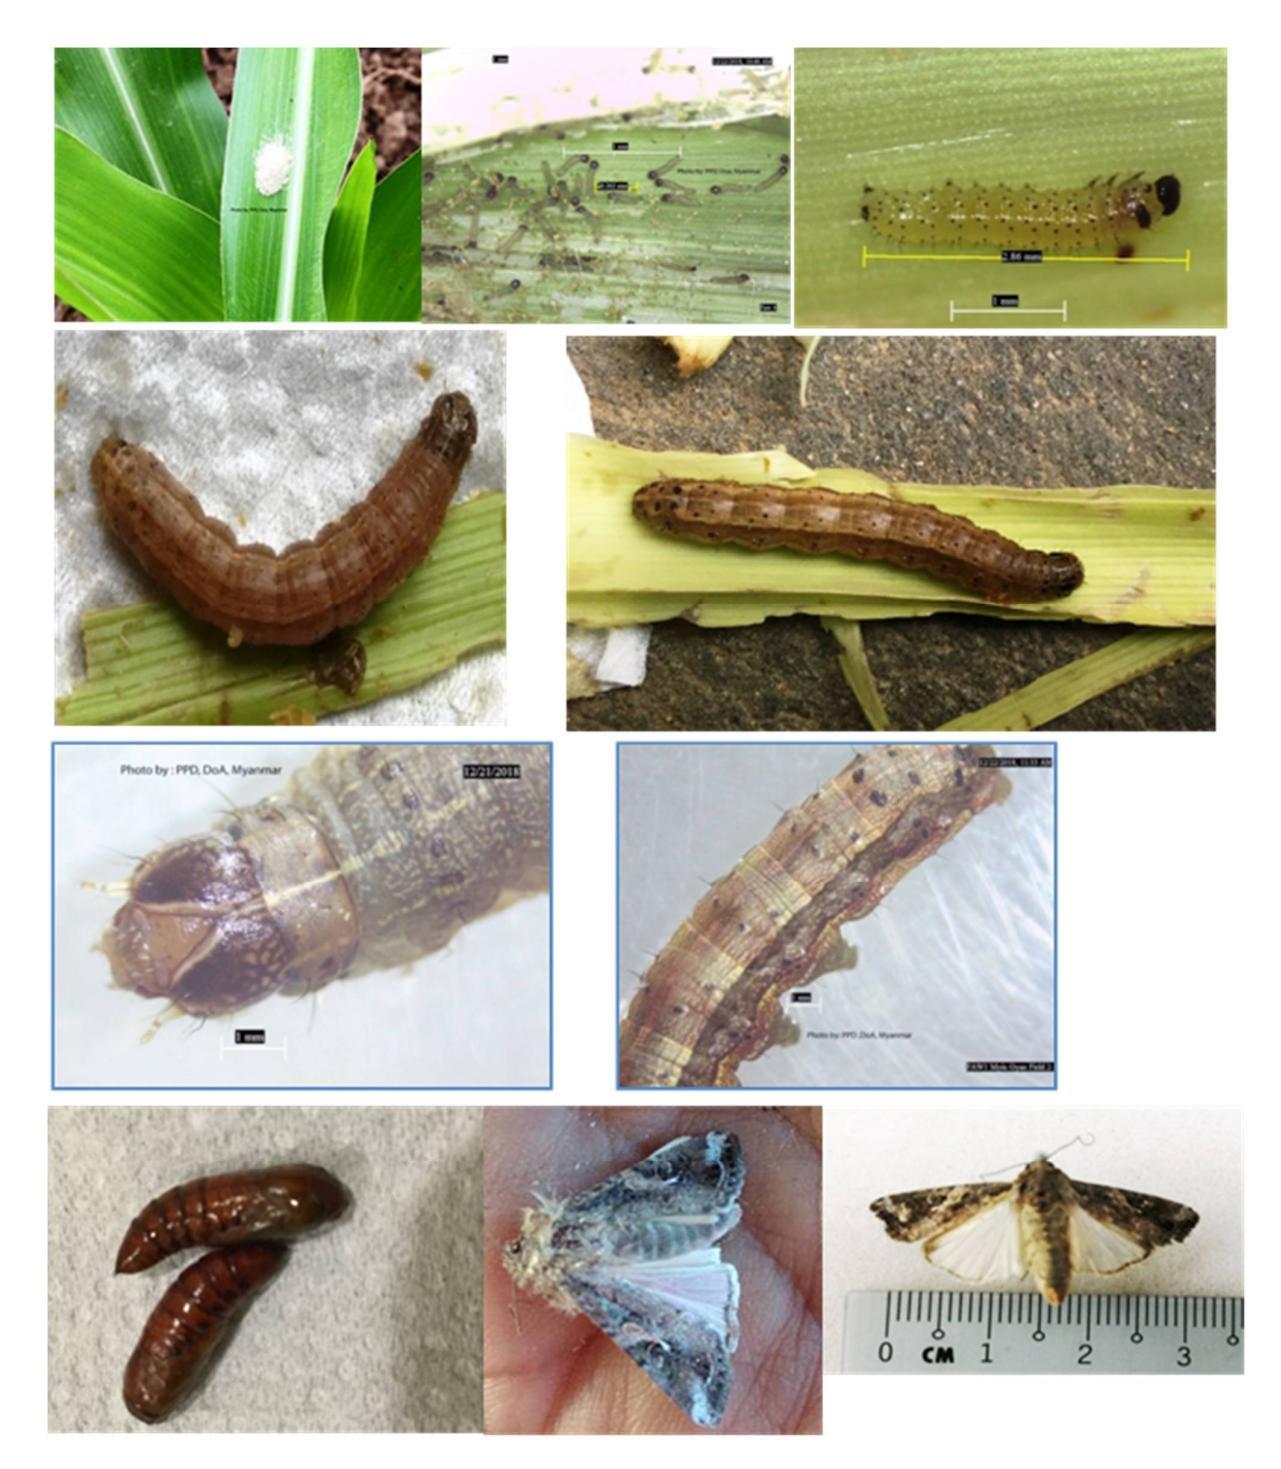
Figure 2. Egg, larvae, pupa and adults of fall armyworm in Myanmar.
